PASSAIC RIVER BASIN  
DEN BROOK, MORRIS COUNTY  
NEW JERSEY

# INDIAN LAKE DAM

PHASE I INSPECTION REPORT  
NATIONAL DAM SAFETY PROGRAM

NJ 00167

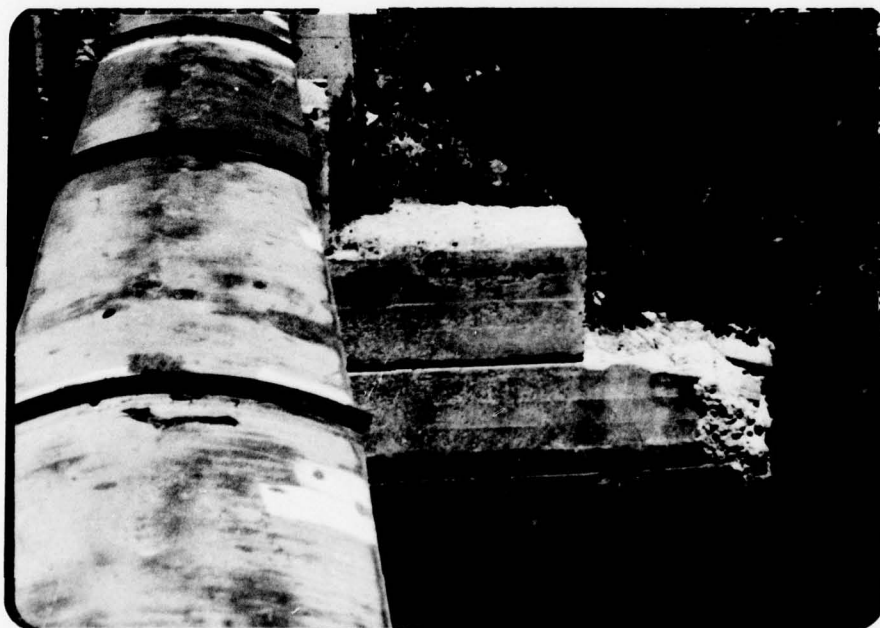
There is some concrete deterioration in the downstream spillway sidewalls and weathering at the spillway construction joints, otherwise the spillway section appears in adequate condition. The concrete bulkhead at the right side of the spillway has cracked and some of the stone facing has fallen out but this is not considered serious.

Deterioration of concrete at left  
downstream sidewall of spillway

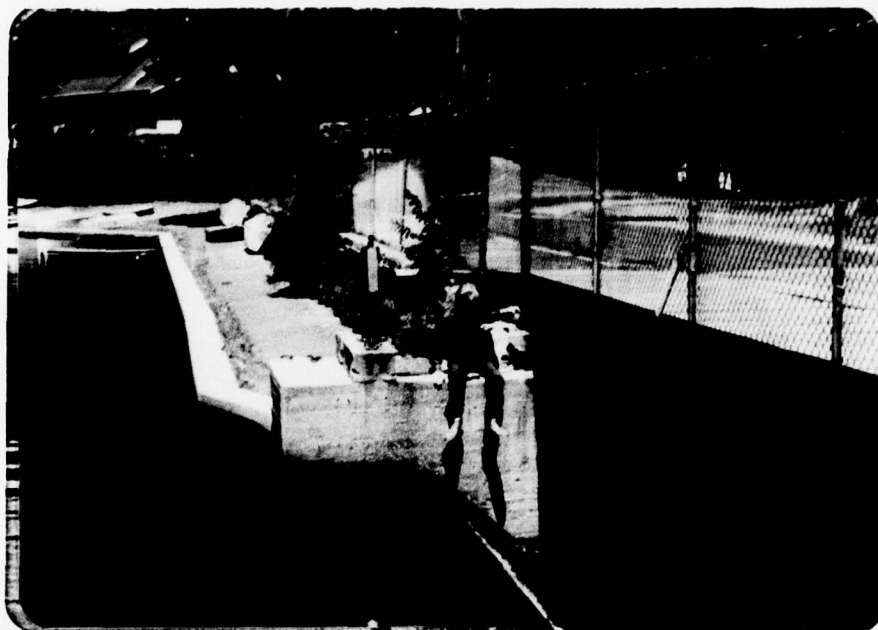
The bottom outlets are in functional condition and the gate valves seem to be in satisfactory condition. They can be easily operated by one man with a ratchet lever handle. The concrete support for the floor stand operator for the control valve at the left side of the spillway has broken up and should be repaired.

Left spillway sidewall and  
drawdown control valve

(2) Within one year repair the concrete support for the floor stand gate operator and the bulkhead.

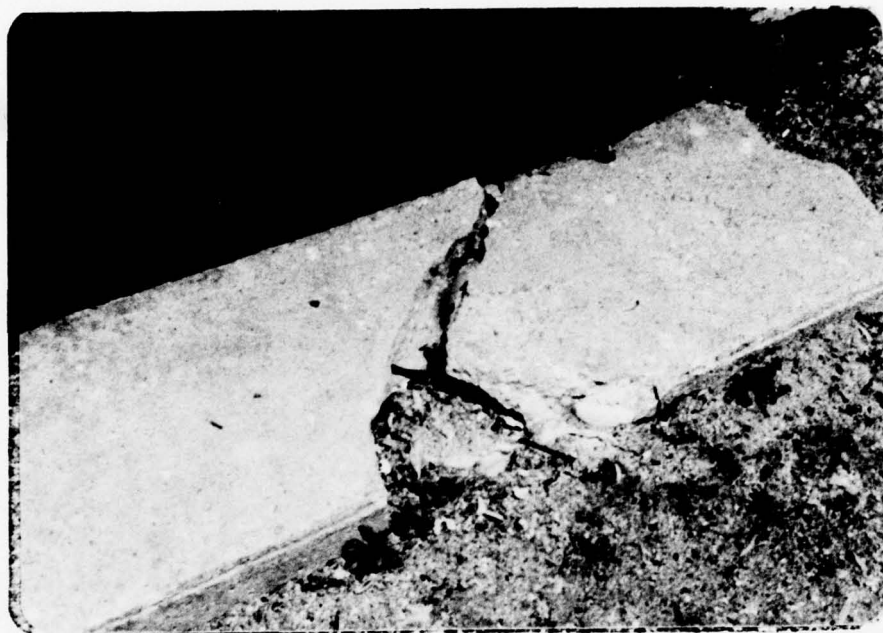
Crack in concrete bulkhead of right upstream section of embankment 5 July 1978

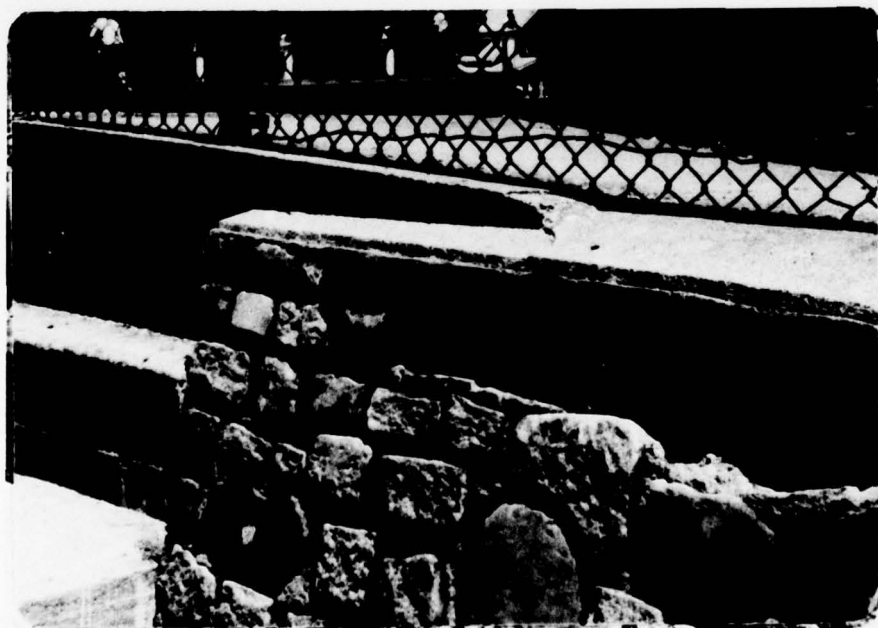
Deterioration of upstream facing of right embankment 5 July 1978

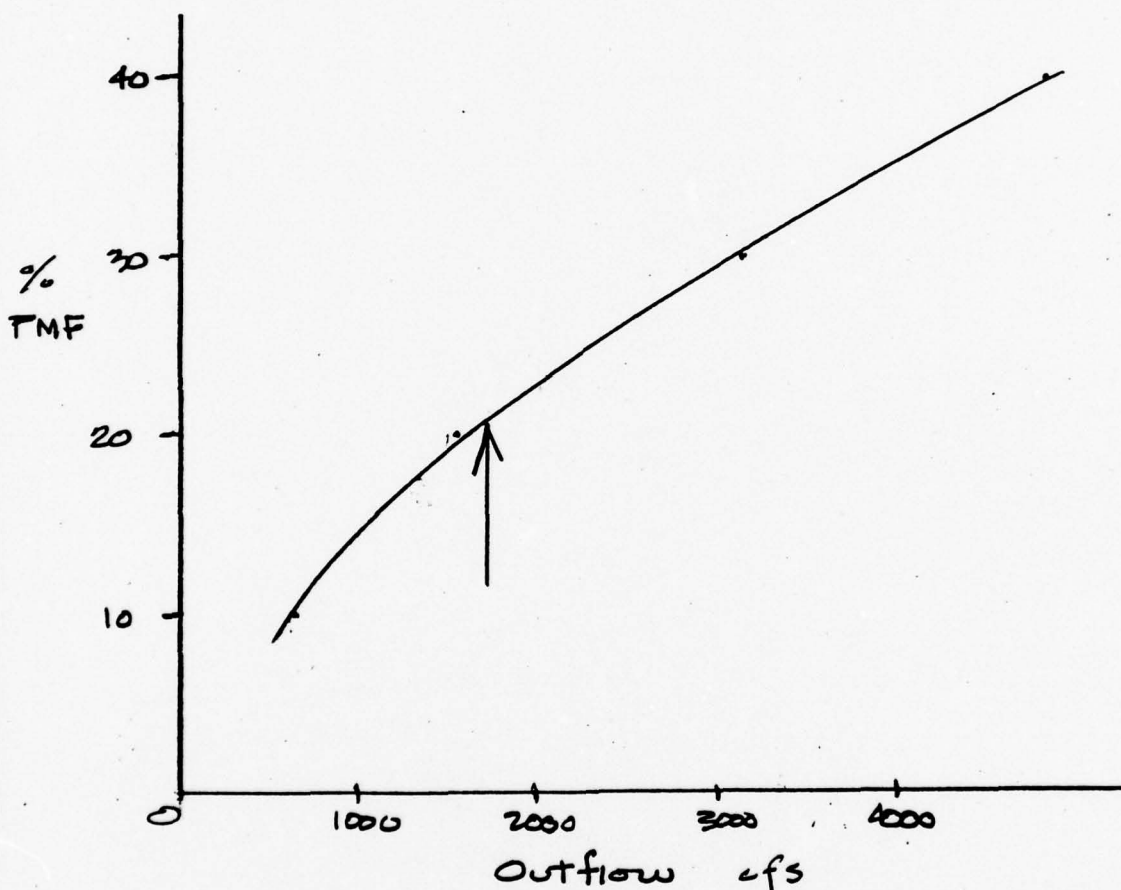
3. Dam overtops at approx el 513.5 with  $Q = 1702 \text{ cfs}$   
 $\therefore$  dam can pass 20% PMF
